Cultural Resources Survey for the Granbury East Wastewater Treatment Plant, City of Granbury, Hood County, Texas (TWDB Project No. 73813)

CULTURAL RESOURCES REPORT

June 2020

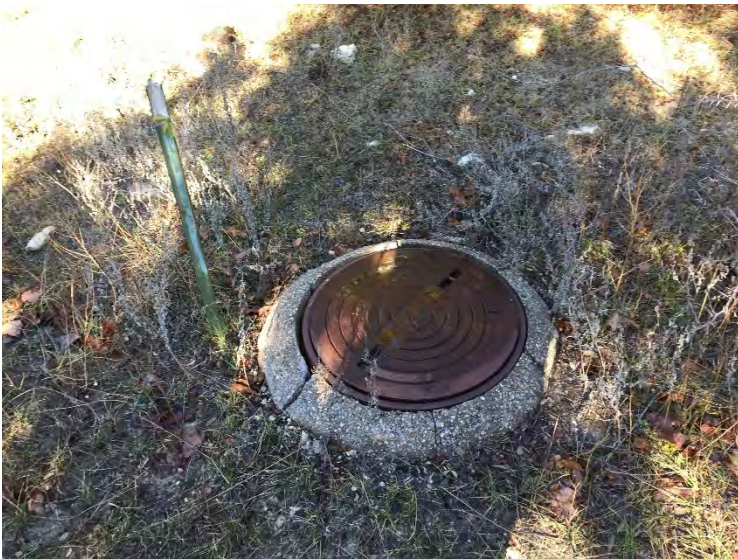
Photograph 15: Modern manhole cover, facing North.

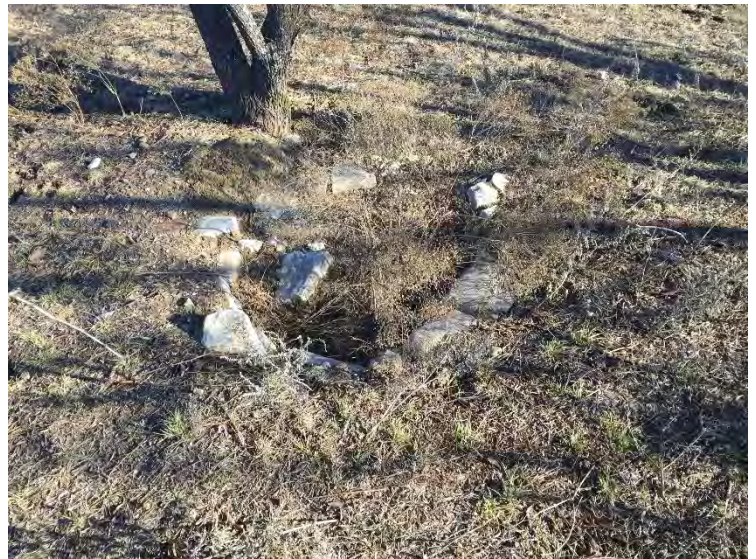
Photograph 16: Site 41HD96, Original Feature 1, well, facing Northeast.

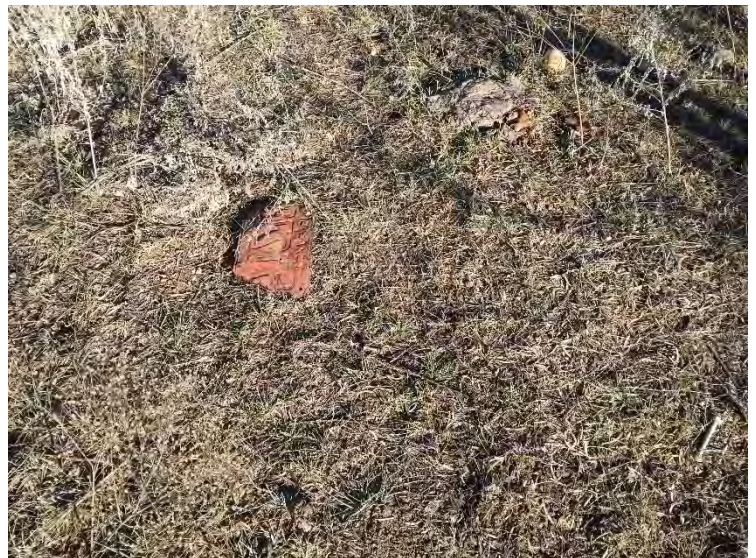
Photograph 18: Site 41HD96, surface debris, facing East.

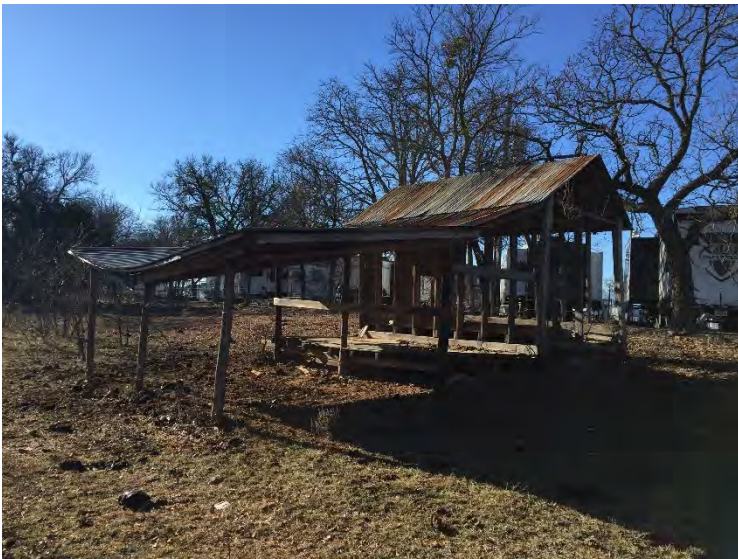
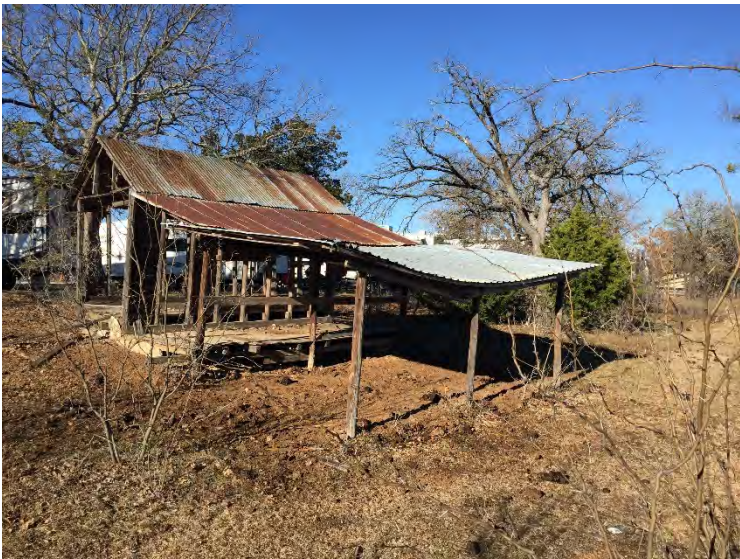
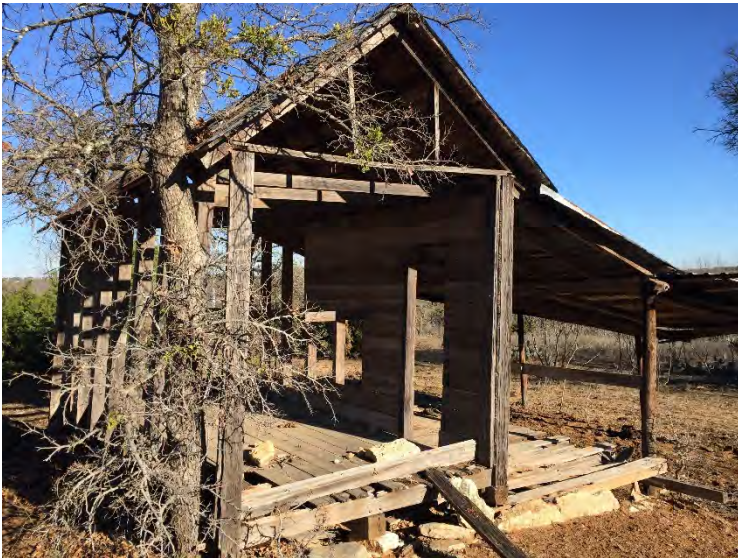
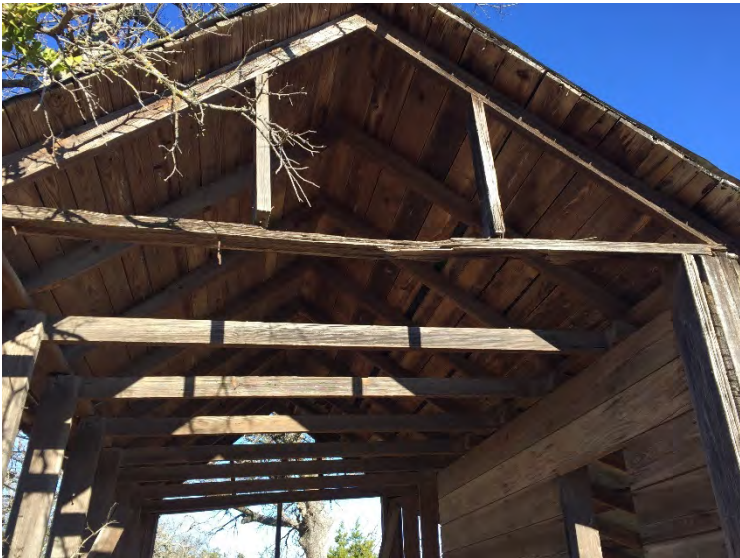
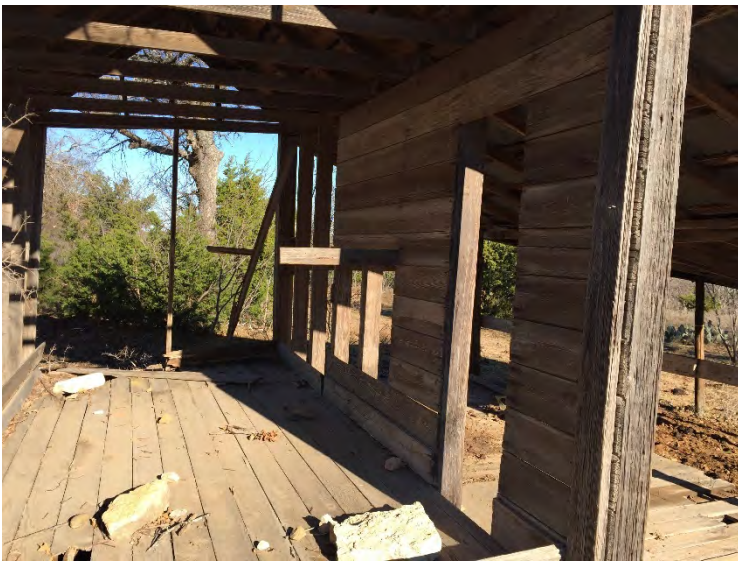
Feature 2 was a typical example of a side-gabled cabin comprised of a single room that was constructed using balloon frame constructions methods (**Appendix A, Photographs 21 through 25**). The building's foundation was comprised of pier and beam resting on the ground's surface or limestone rock. The majority of the walls contained exposed studs, but a section of wall illustrated the cabin was once cladded in horizontal milled wood boards. The roof was comprised of milled wood clad in iron sheets rolled in a simple 2 ½-in x ½-in wavy profile. At some point in modern times, the original shed extension covering the front porch was extended off the front porch to provide additional storage space. This modern shed extension was supported by round wooden poles and a galvanized tin roof pressed in a "U"-shaped profile. At the time of field survey, Feature 2 was dilapidated and considered an archeological ruin.

Photograph 21: 41HD96, Feature 2, barn exterior, facing Southeast.

Photograph 22: 41HD96, Feature 2, barn exterior, facing Northwest.

Photograph 23: 41HD96, Feature 2, barn interior, facing North.

Photograph 24: 41HD96, Feature 2, barn interior, facing North.

Photograph 25: 41HD96, Feature 2, barn interior, facing North.

Feature 2 was a typical example of a side-gabled cabin comprised of a single room that was constructed using balloon frame constructions methods. The building's foundation was comprised of pier and beam resting on the ground's surface or limestone rock. The majority of the walls contained exposed studs, but a section of wall illustrated the cabin was once clad in horizontal milled wood boards. The roof was comprised of milled wood

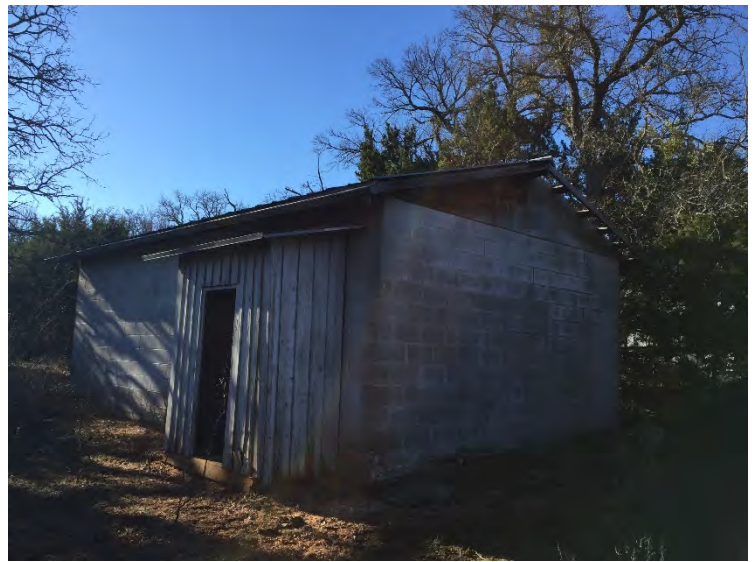
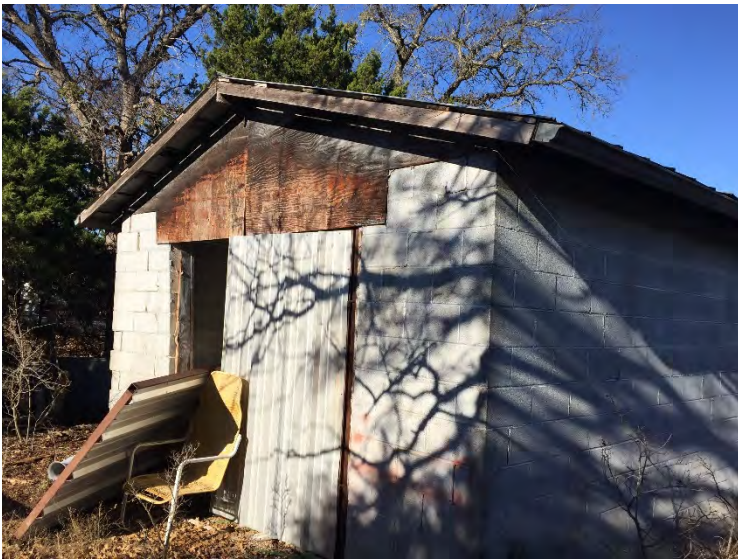
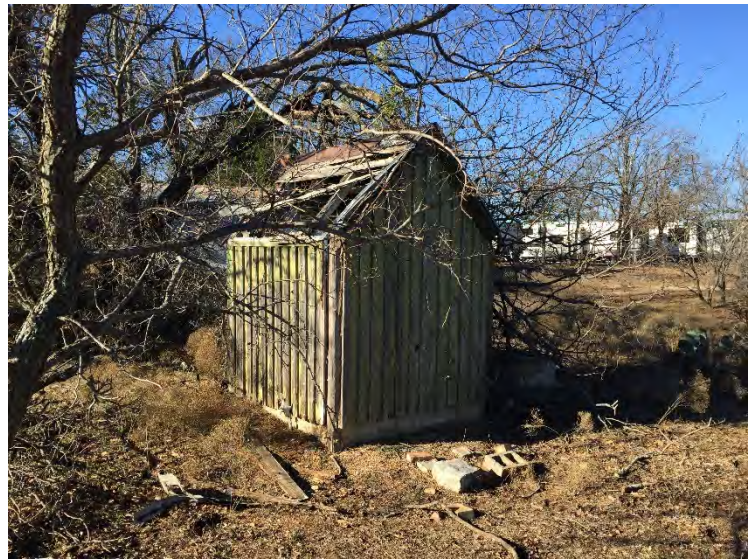
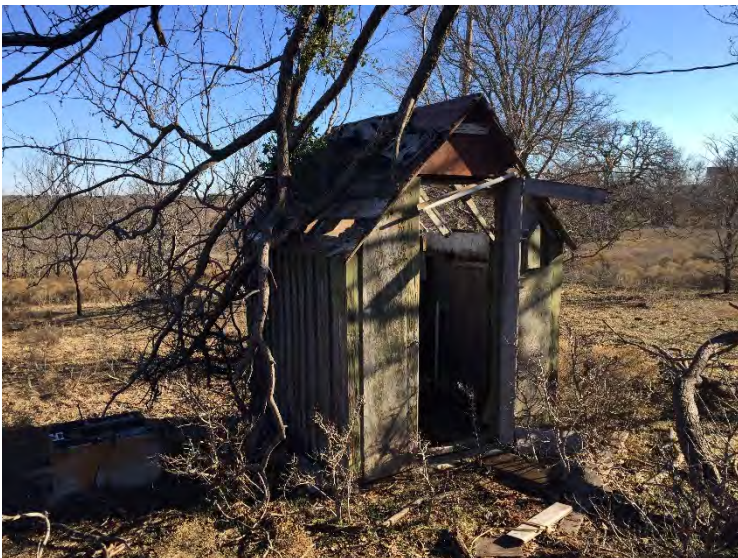
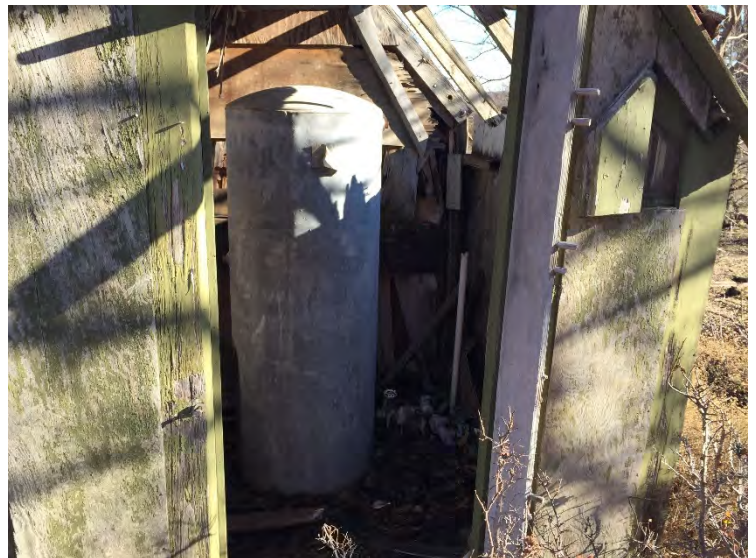
The southern building consisted of a modern, front gabled storage building constructed from cinderblocks. A variety of furniture debris was observed within the shed, which included tables, cabinets, and a refrigerator (**Appendix A, Photographs 26 and 27**). As detailed in *Section 3.2.2.3* of this report, this building was constructed between 1976 and 1981. A modern outbuilding was located to the south of the modern storage building and consisted of a small utility shed constructed using milled wood framing and roofing. The shed contained a modern water heater and piping (**Appendix A, Photographs 29 through 30**).

Photograph 26: 41HD96, modern structure, facing Southwest.

Photograph 27: 41HD96, modern structure, facing Northwest.

Photograph 28: 41HD96, modern structure, facing West.

Photograph 29: 41HD96, modern structure, facing Northeast.

Photograph 30: 41HD96, modern structure, facing Northeast.
